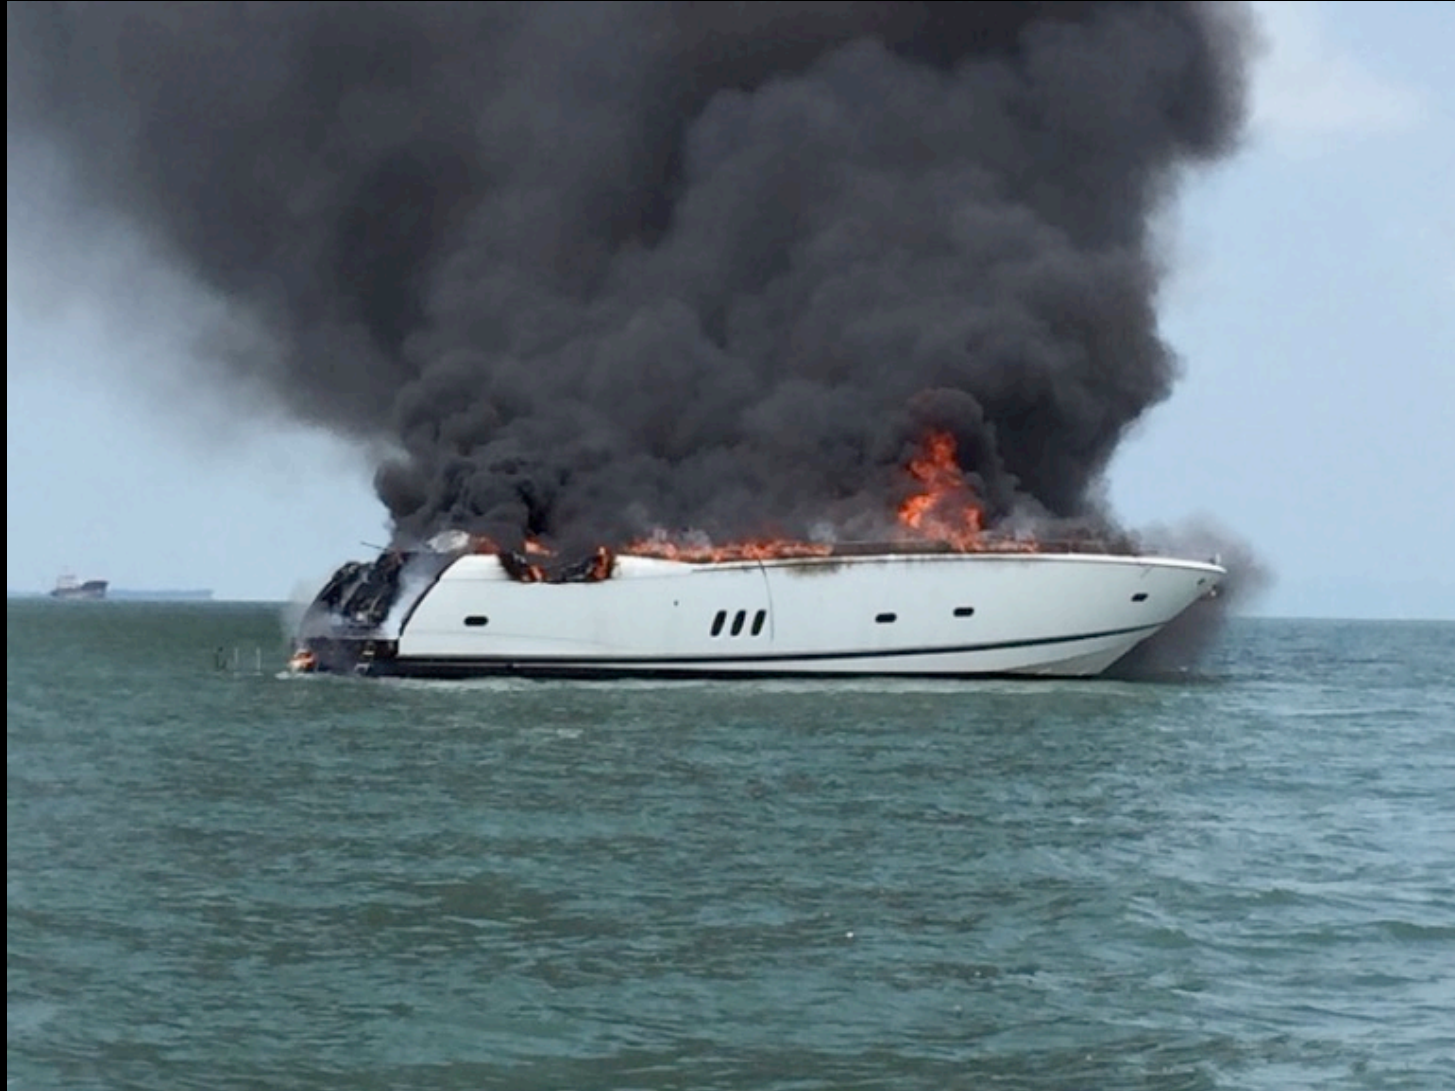
FIRE: Singapore

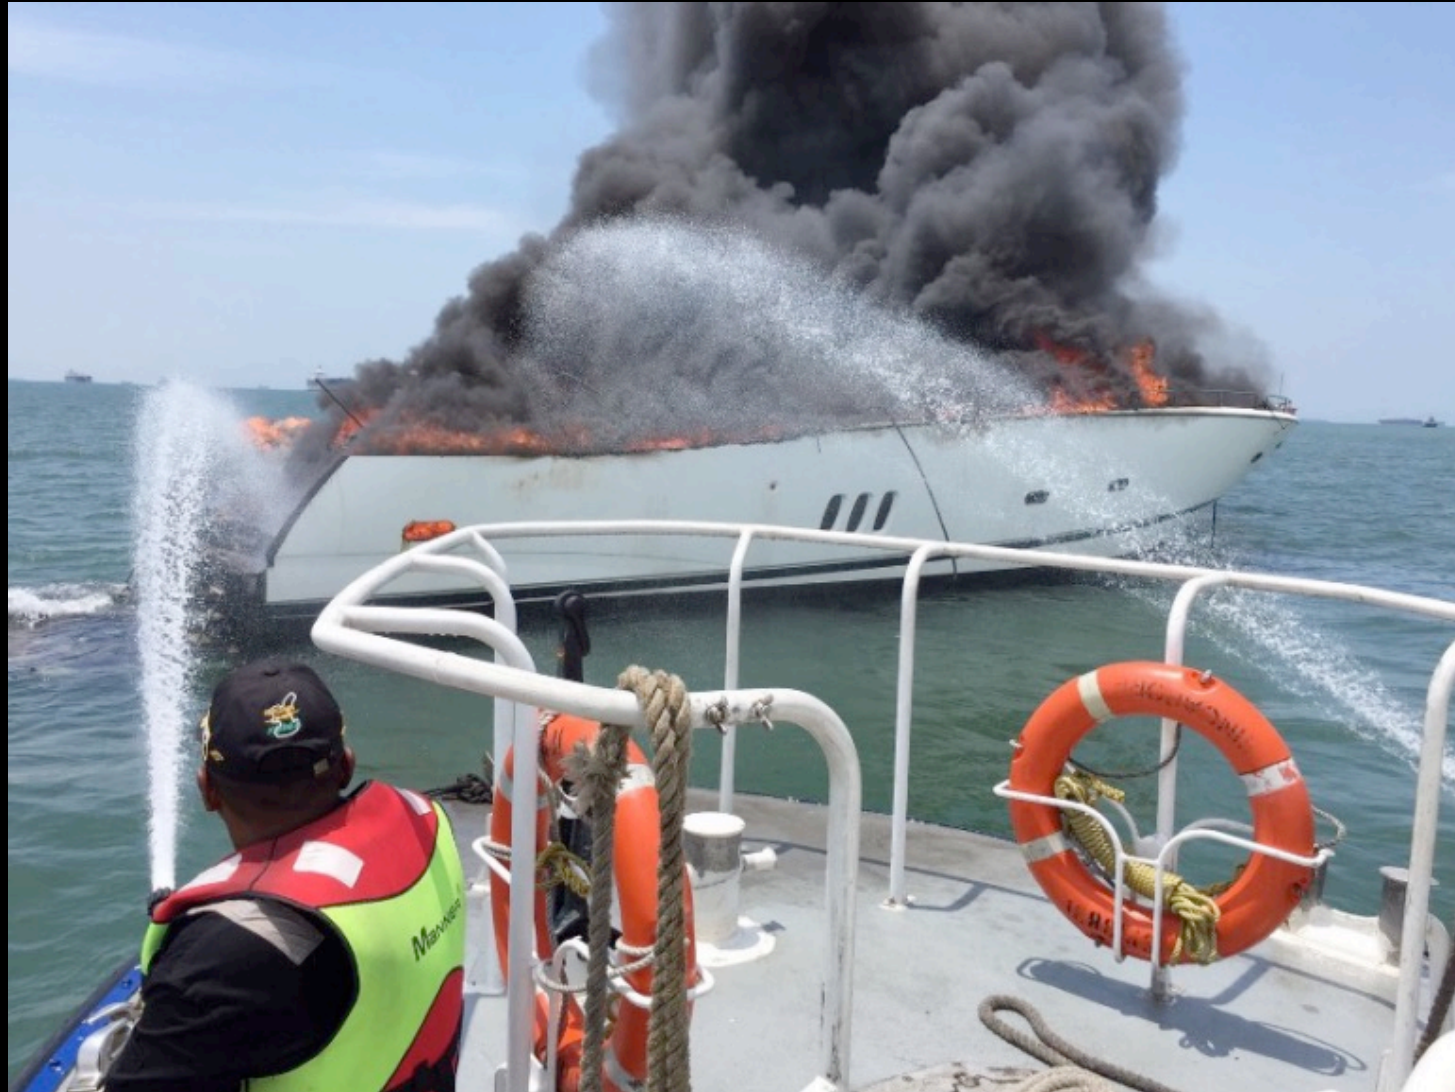
FIRE: Singapore

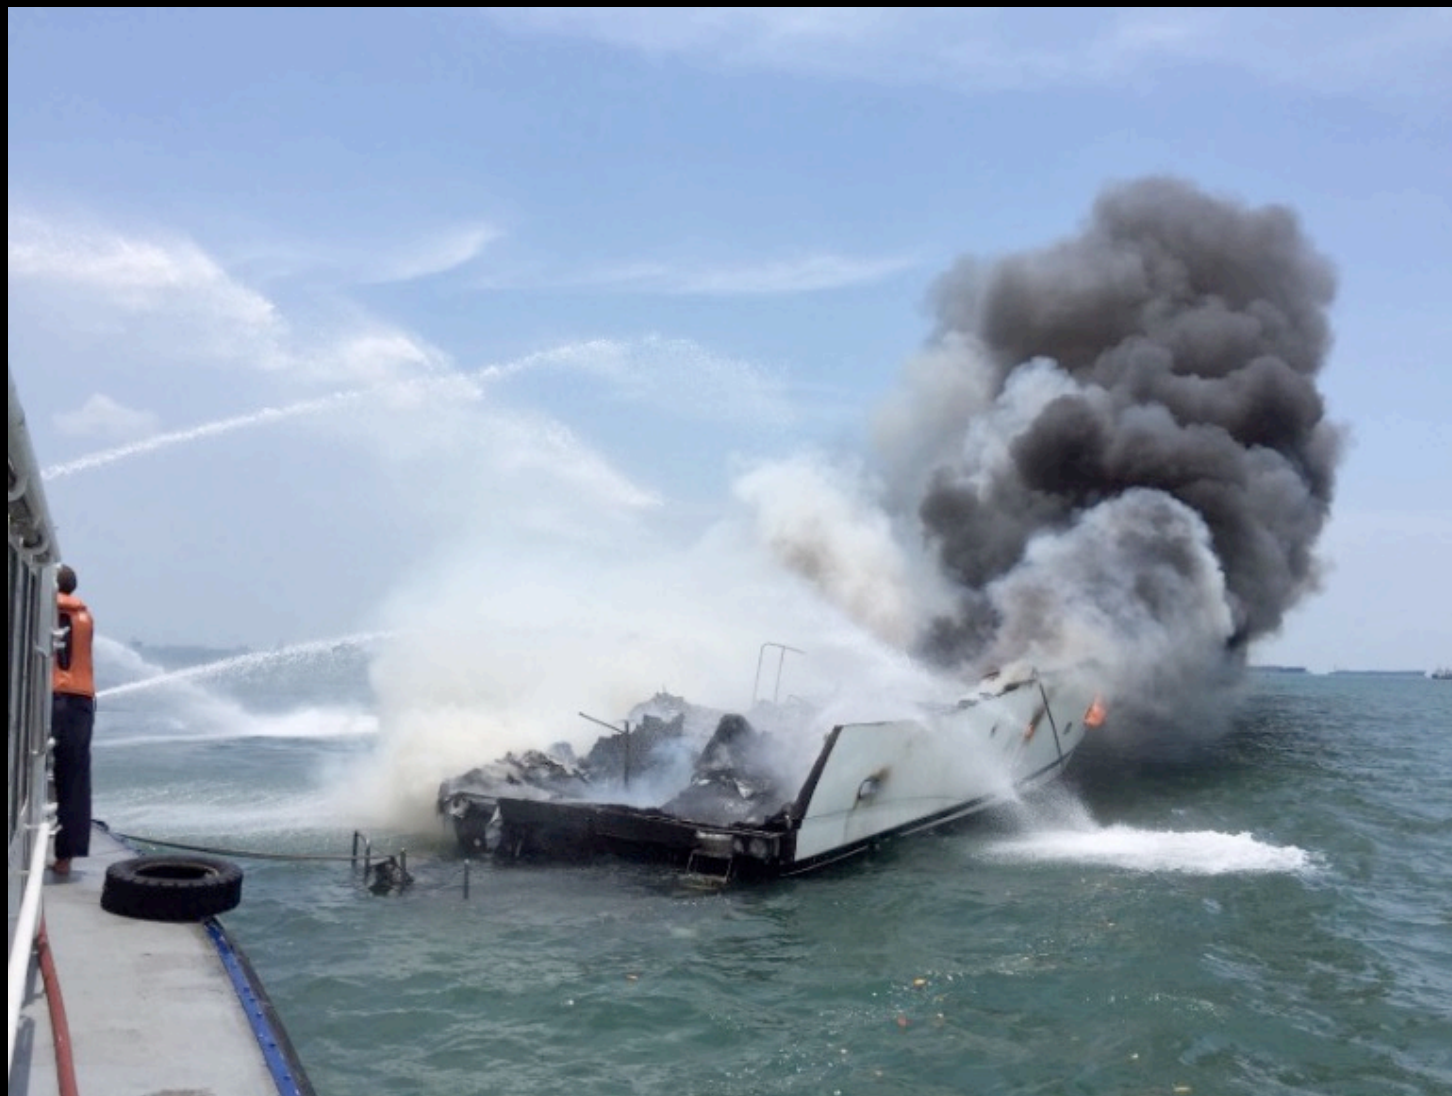
FIRE: Prior to sinking

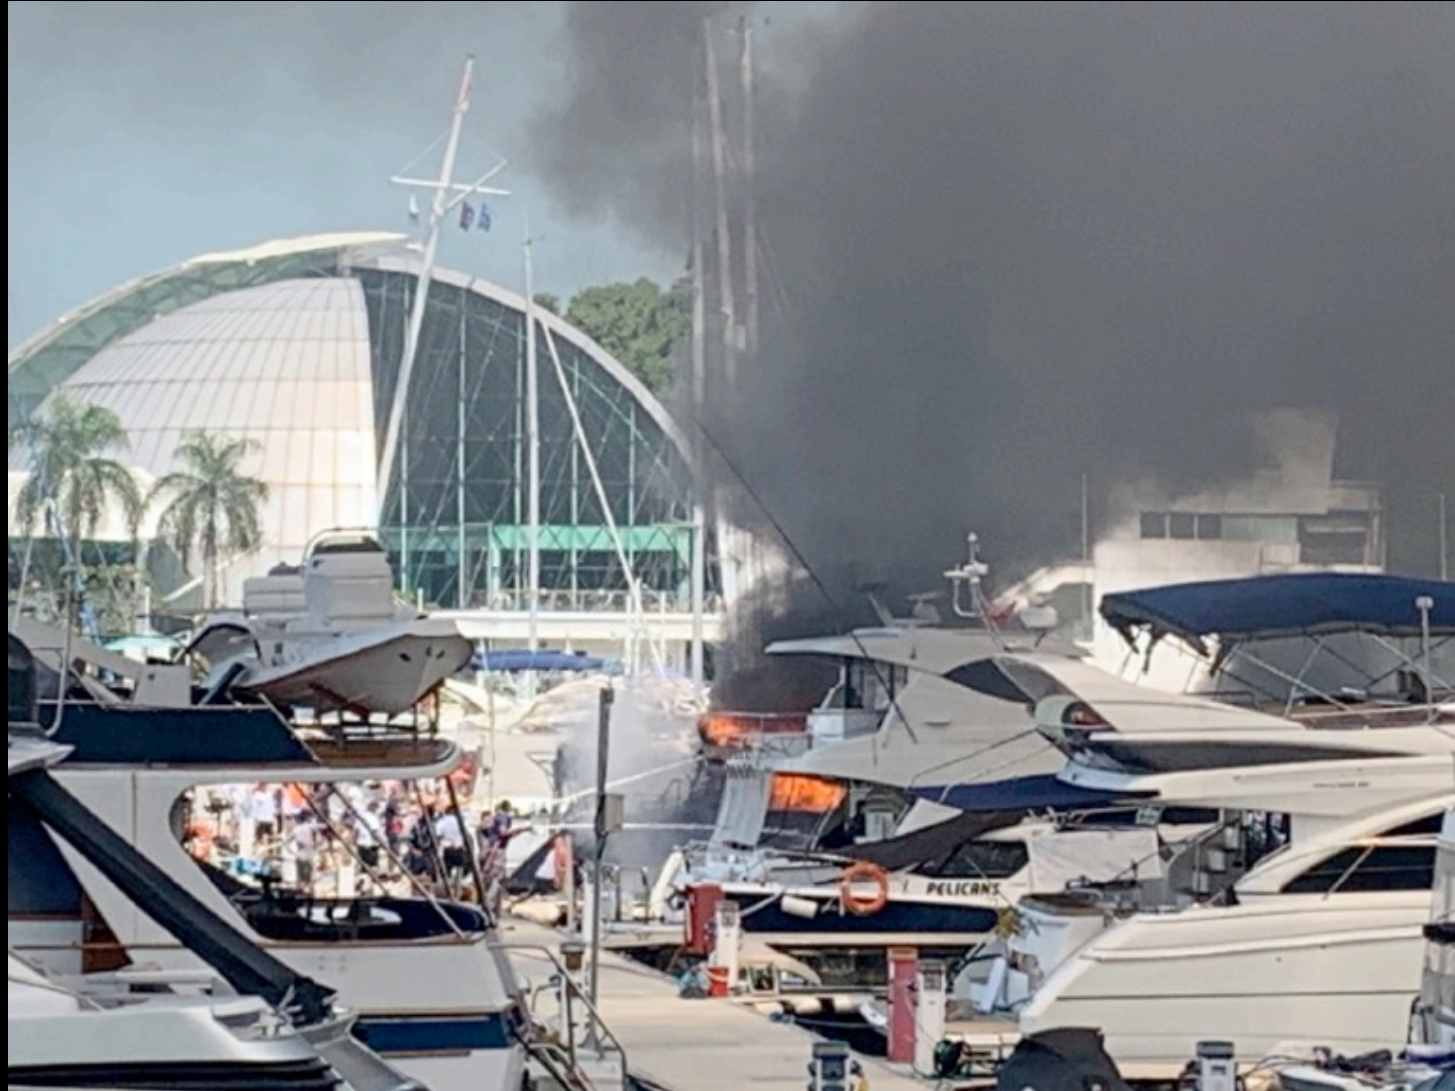
FIRE: Singapore 30th May 2022

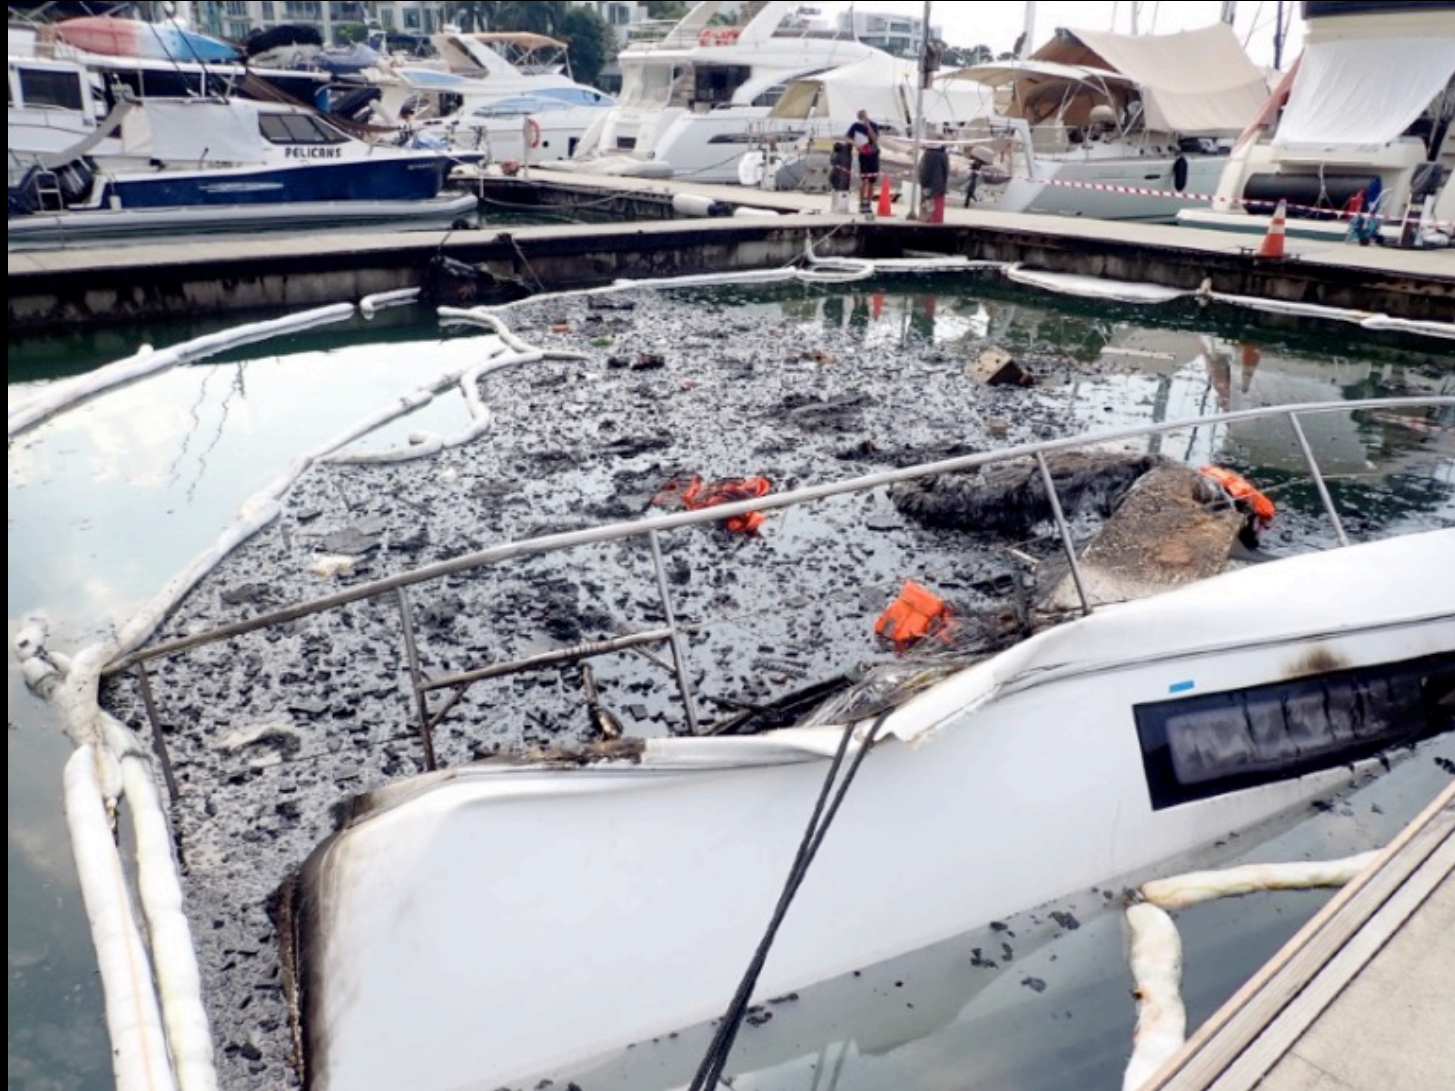
31st May

– after fire & prior to sinking in Marina

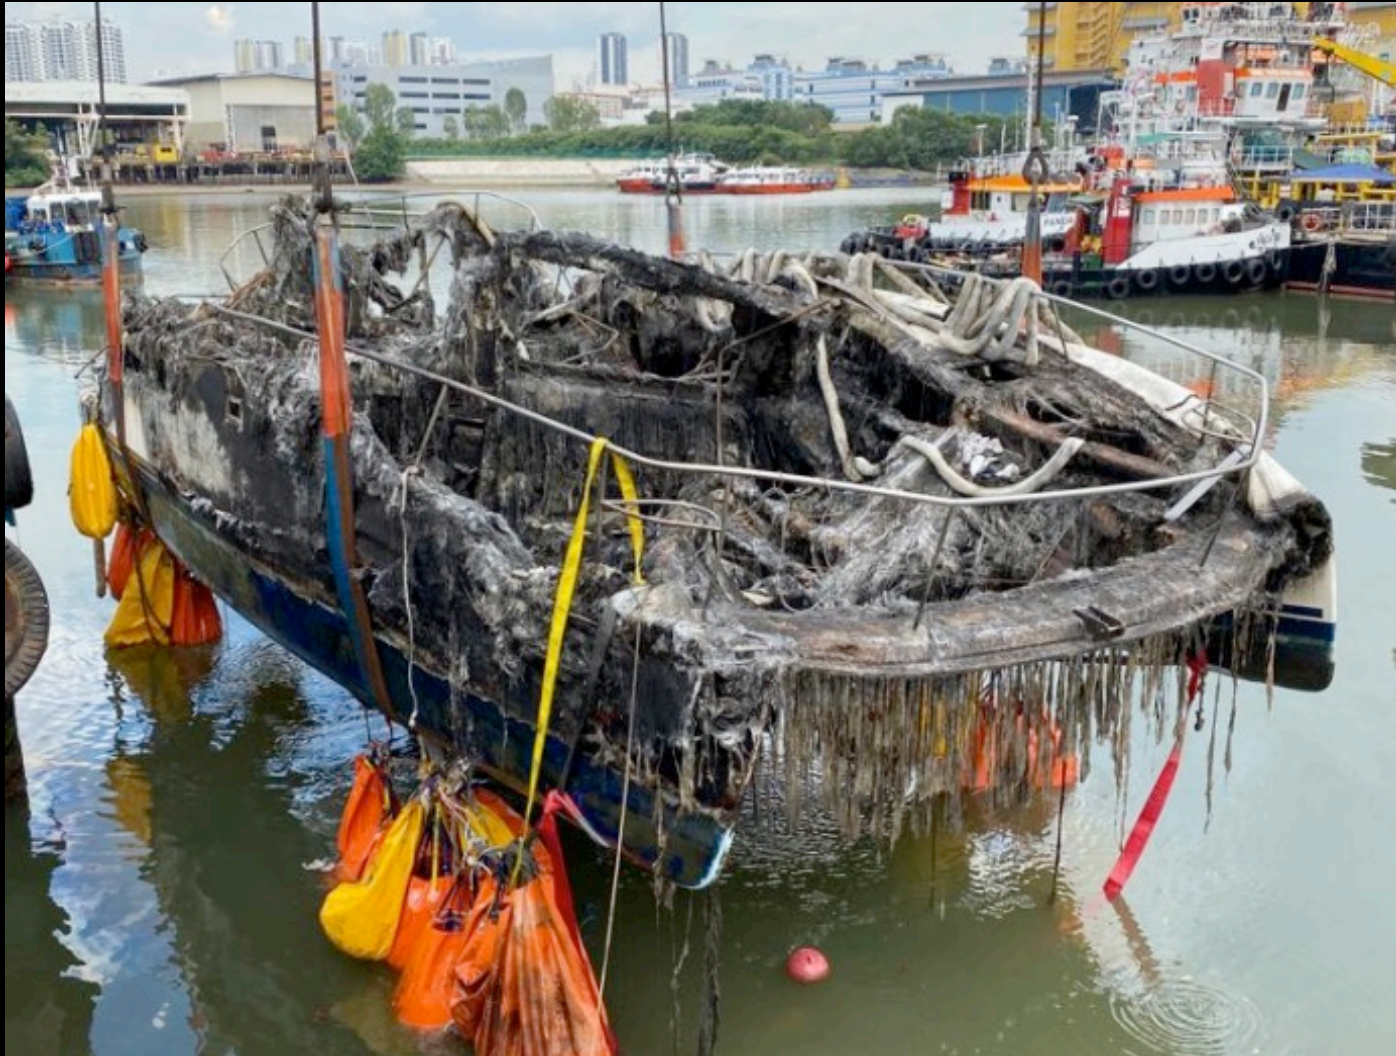
Salvaged remains being lifted from barge for disposal

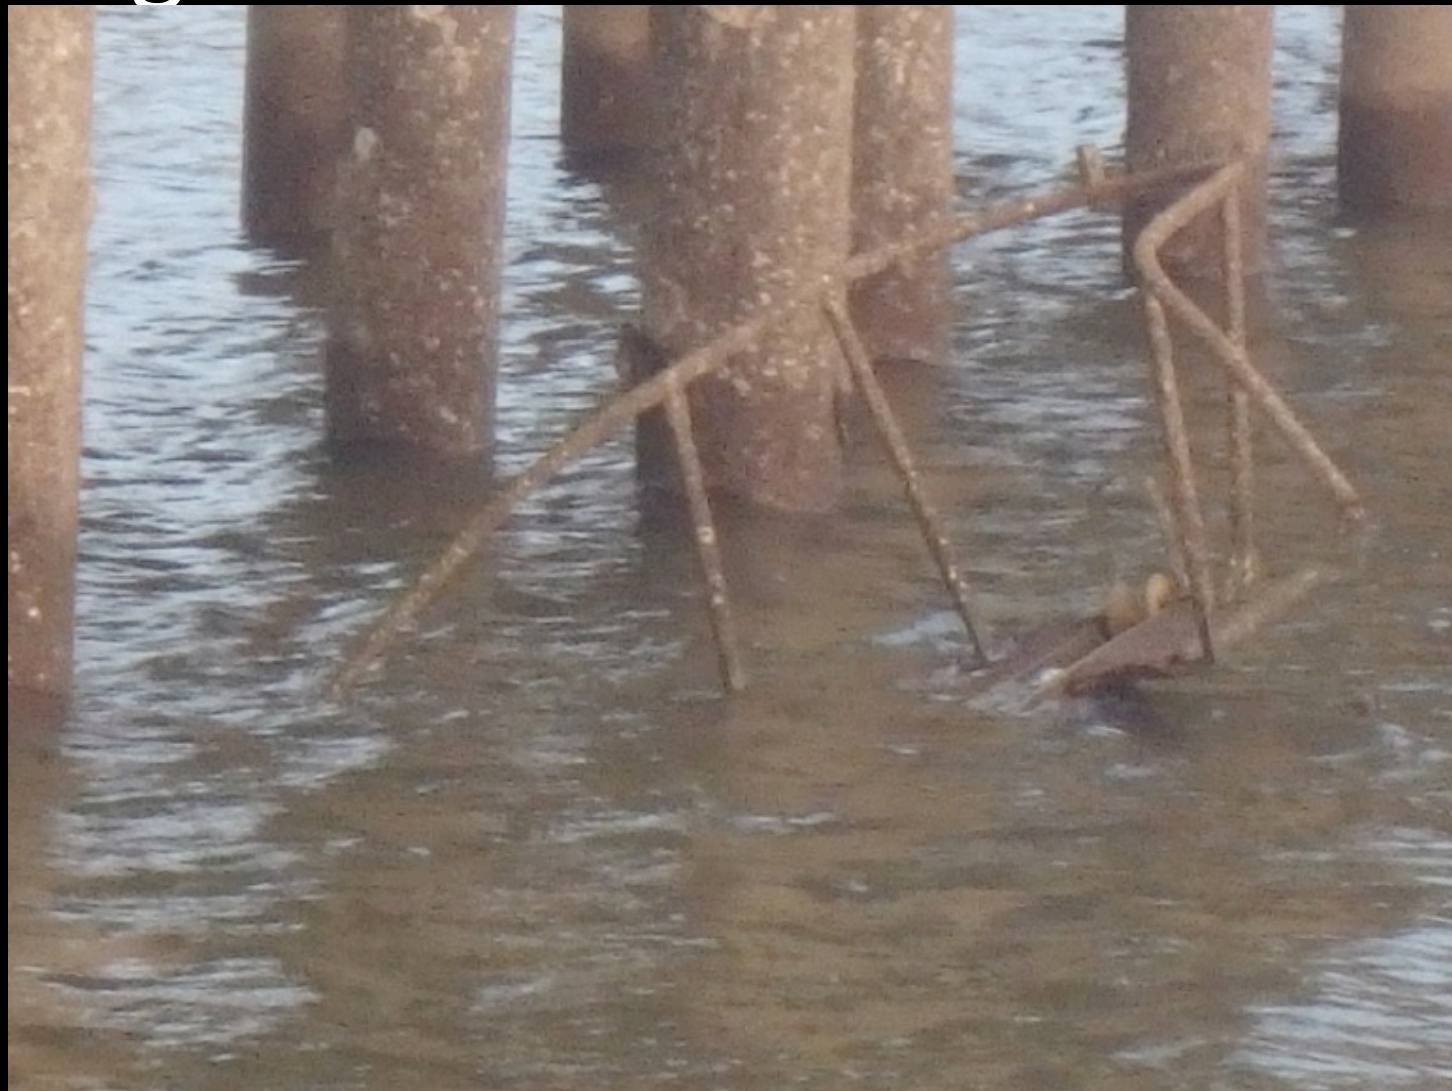
FIRE MALAYSIA “Remains of motor yacht which caught on fire and sank”

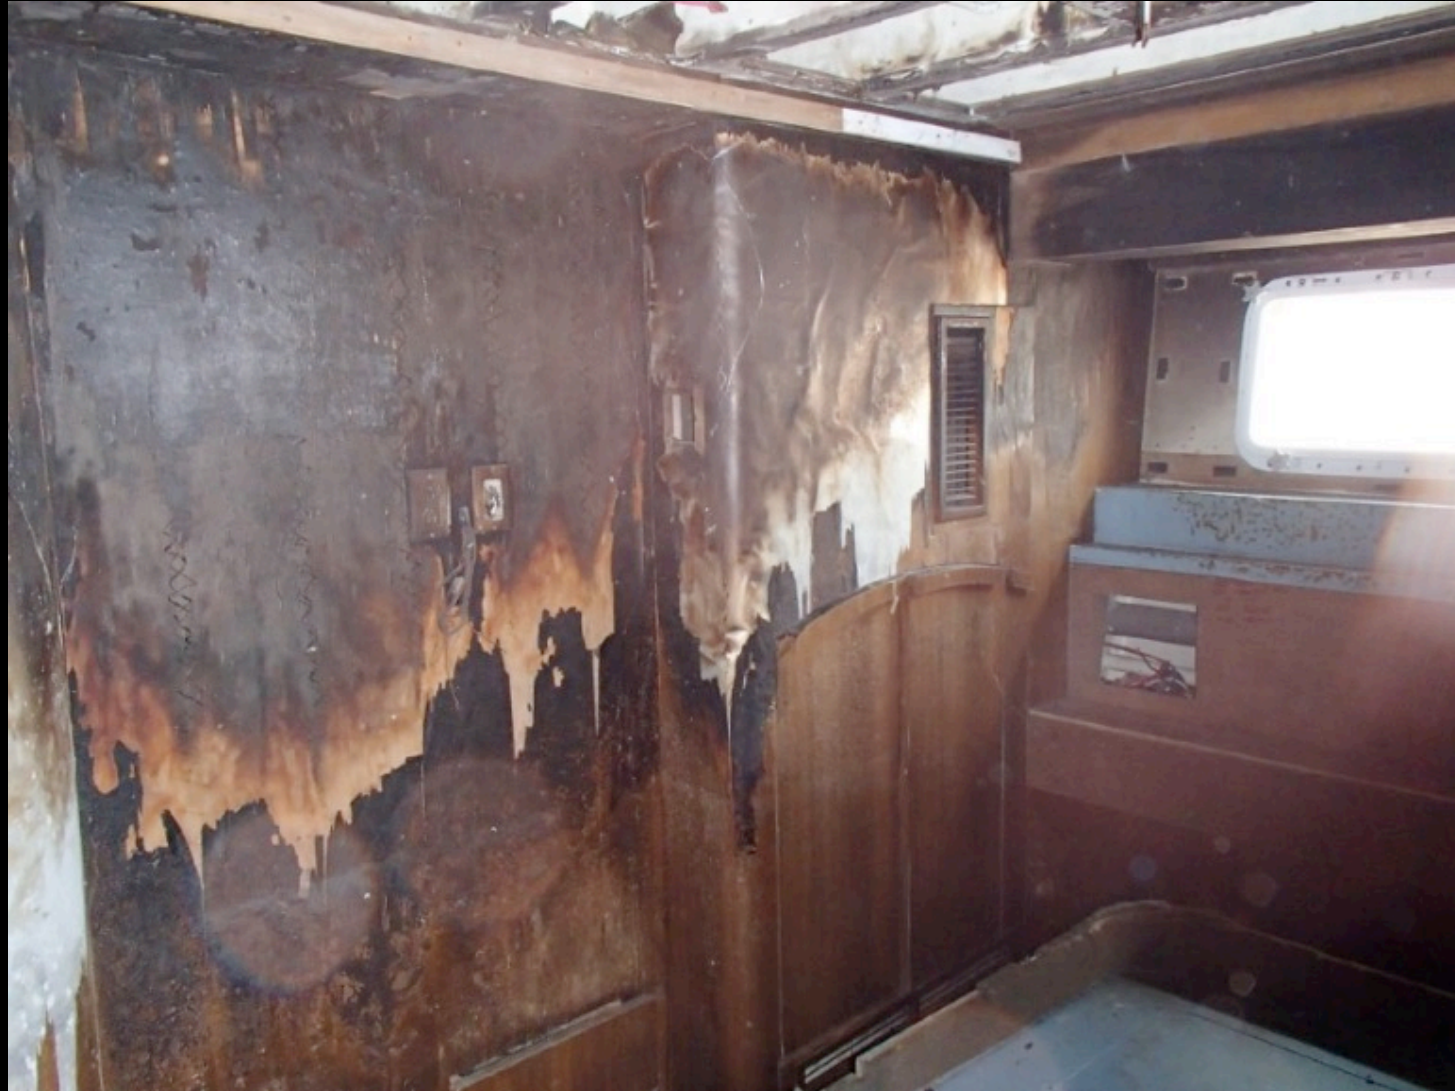
FIRE: Thailand

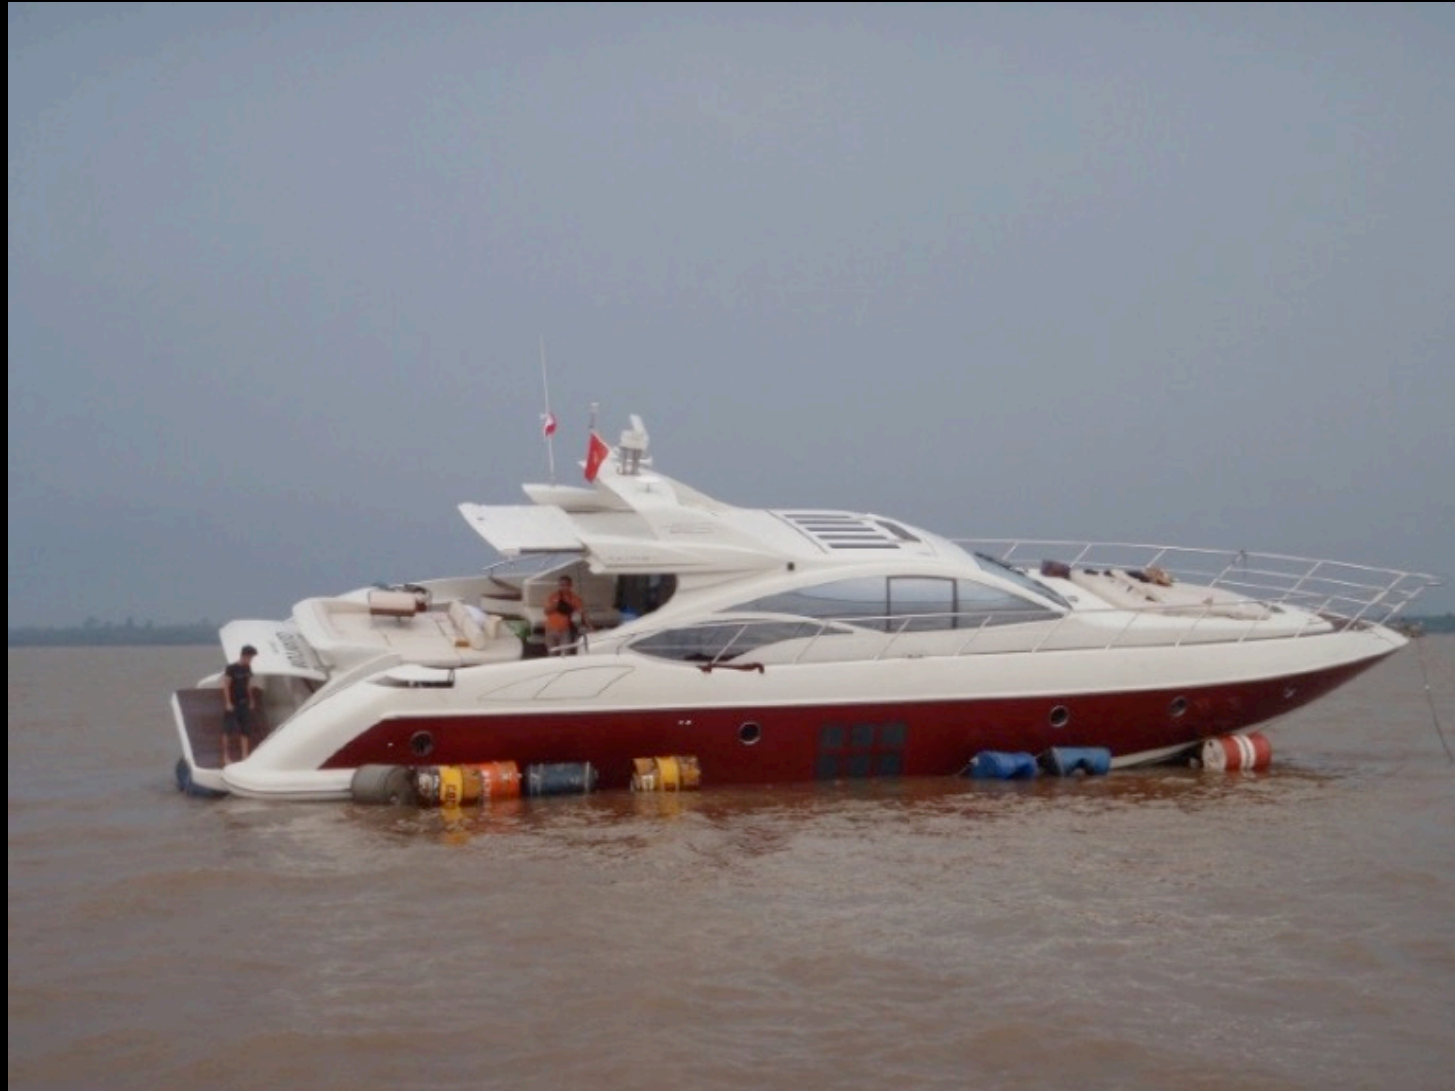
GROUNDING: Indonesia

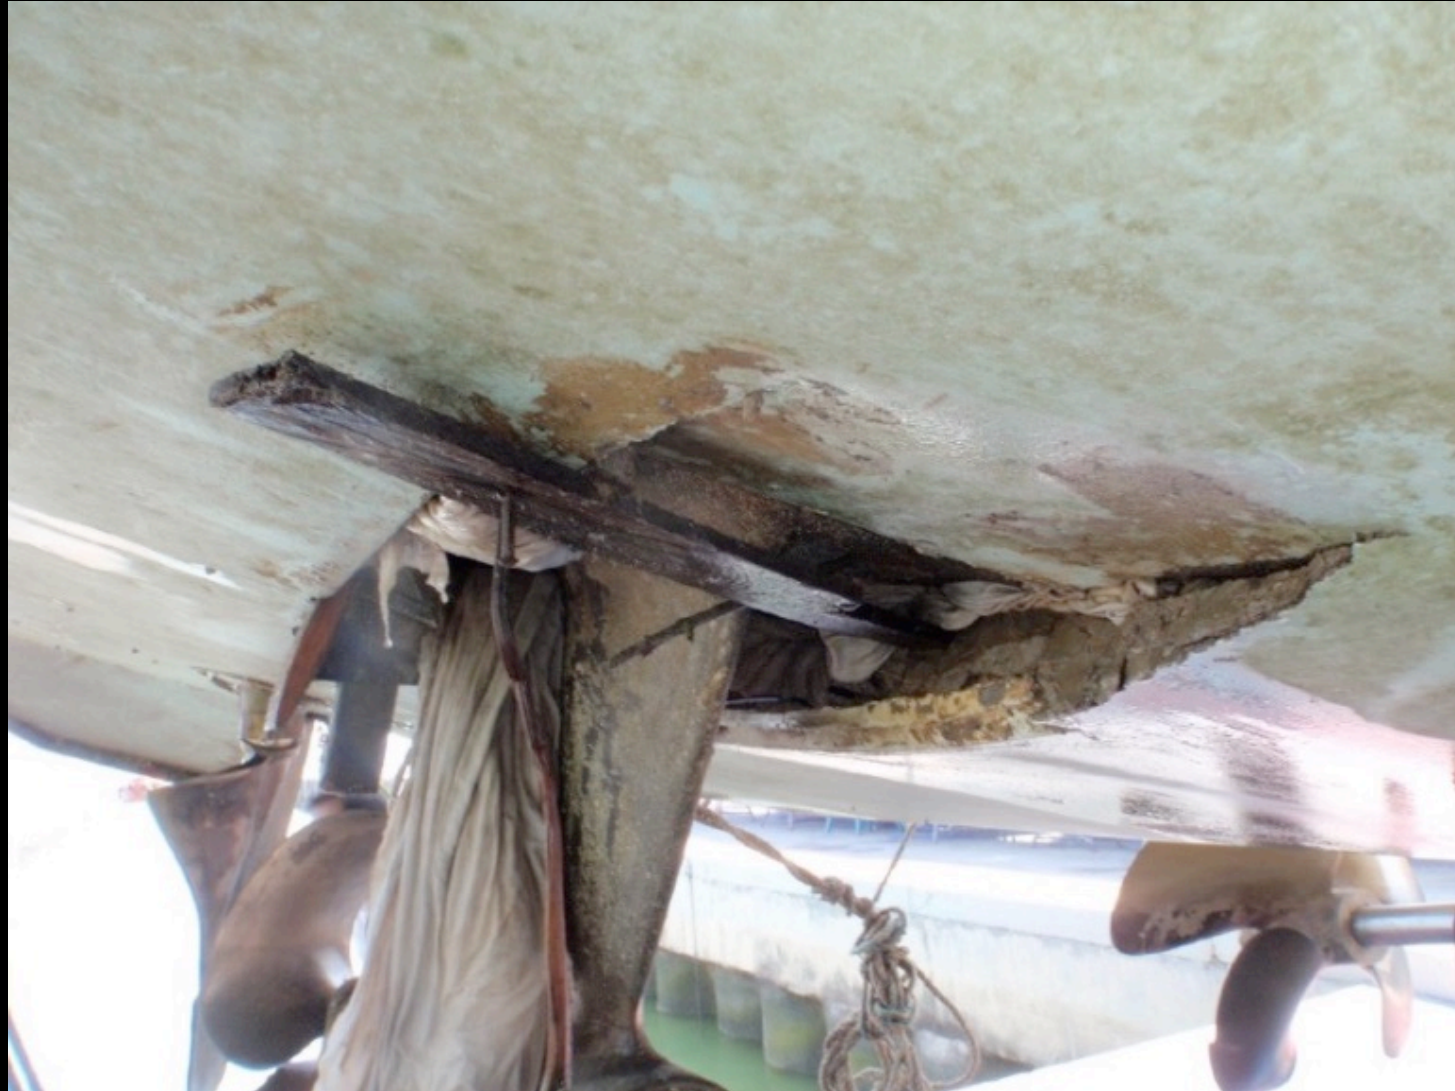
GROUNDING:

Prop-shaft 'I' bracket pushed through hull, vessel flooded

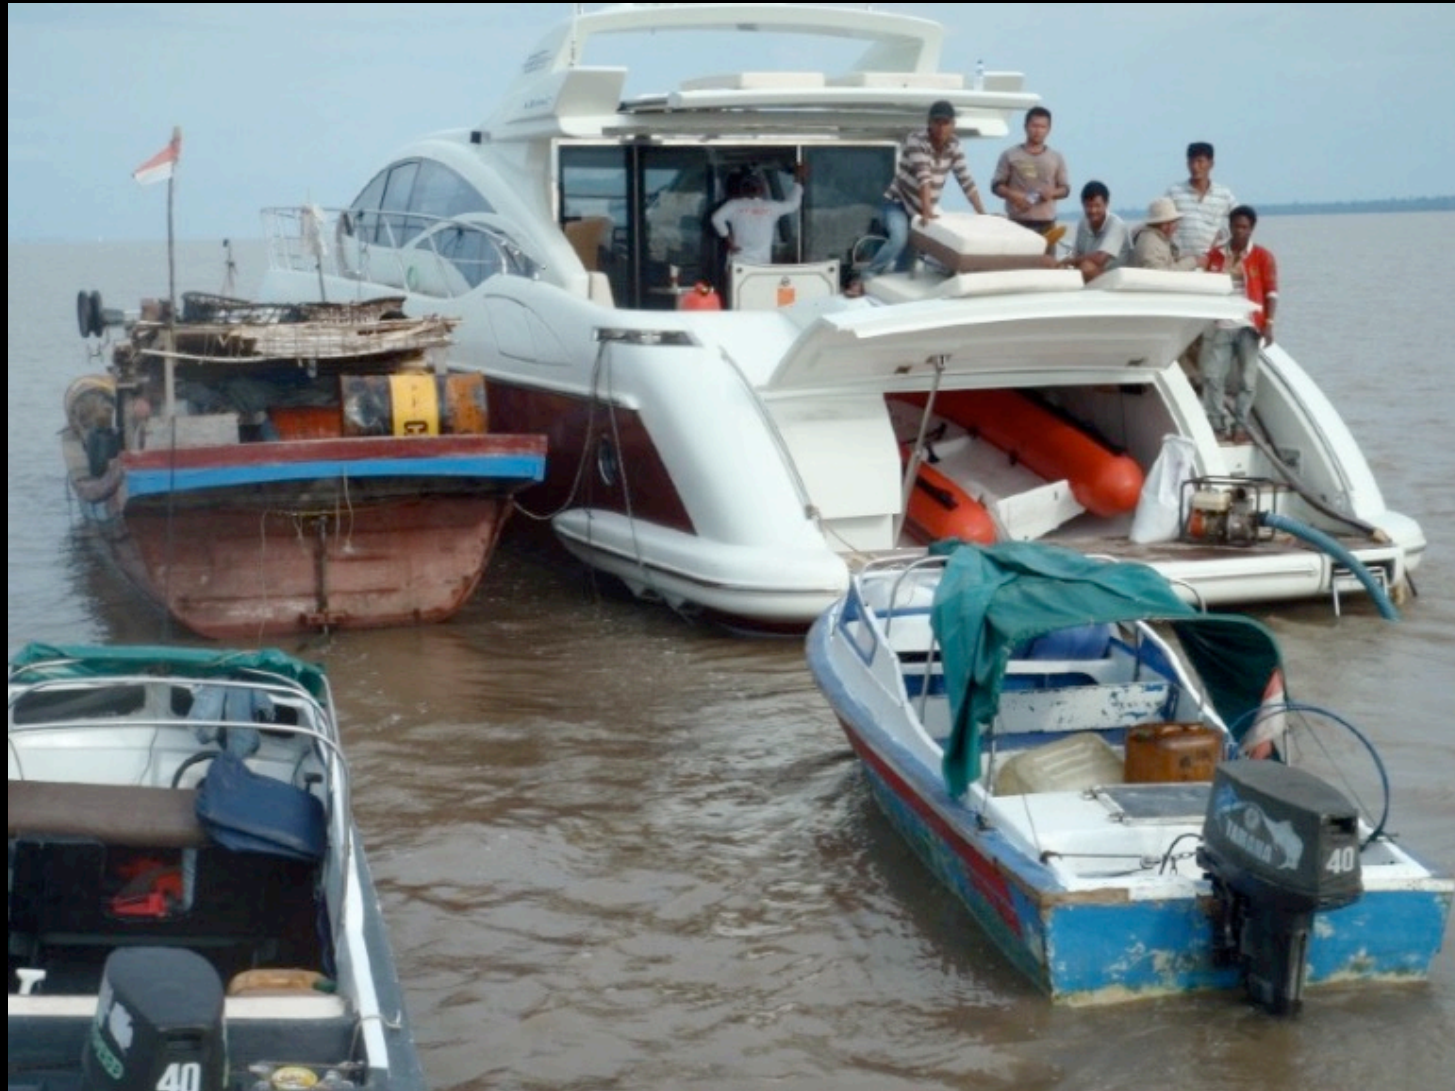
GROUNDING: Re-floated. Yacht eventually CTL

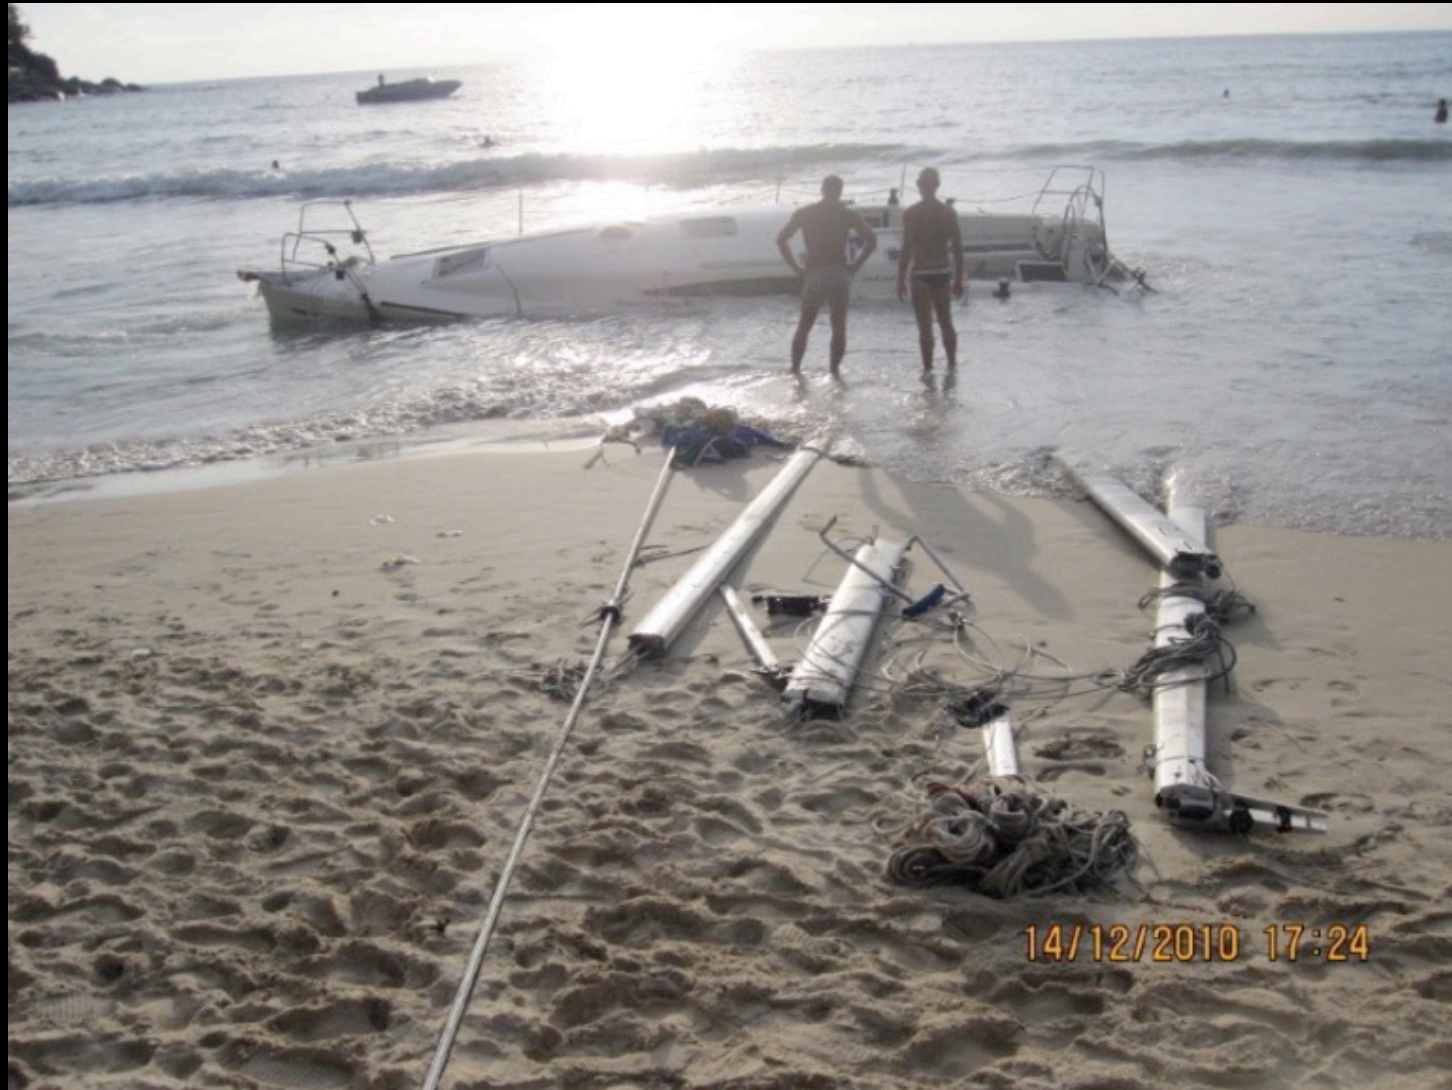
GROUNDING:

Thailand, after another vessel dragged anchor

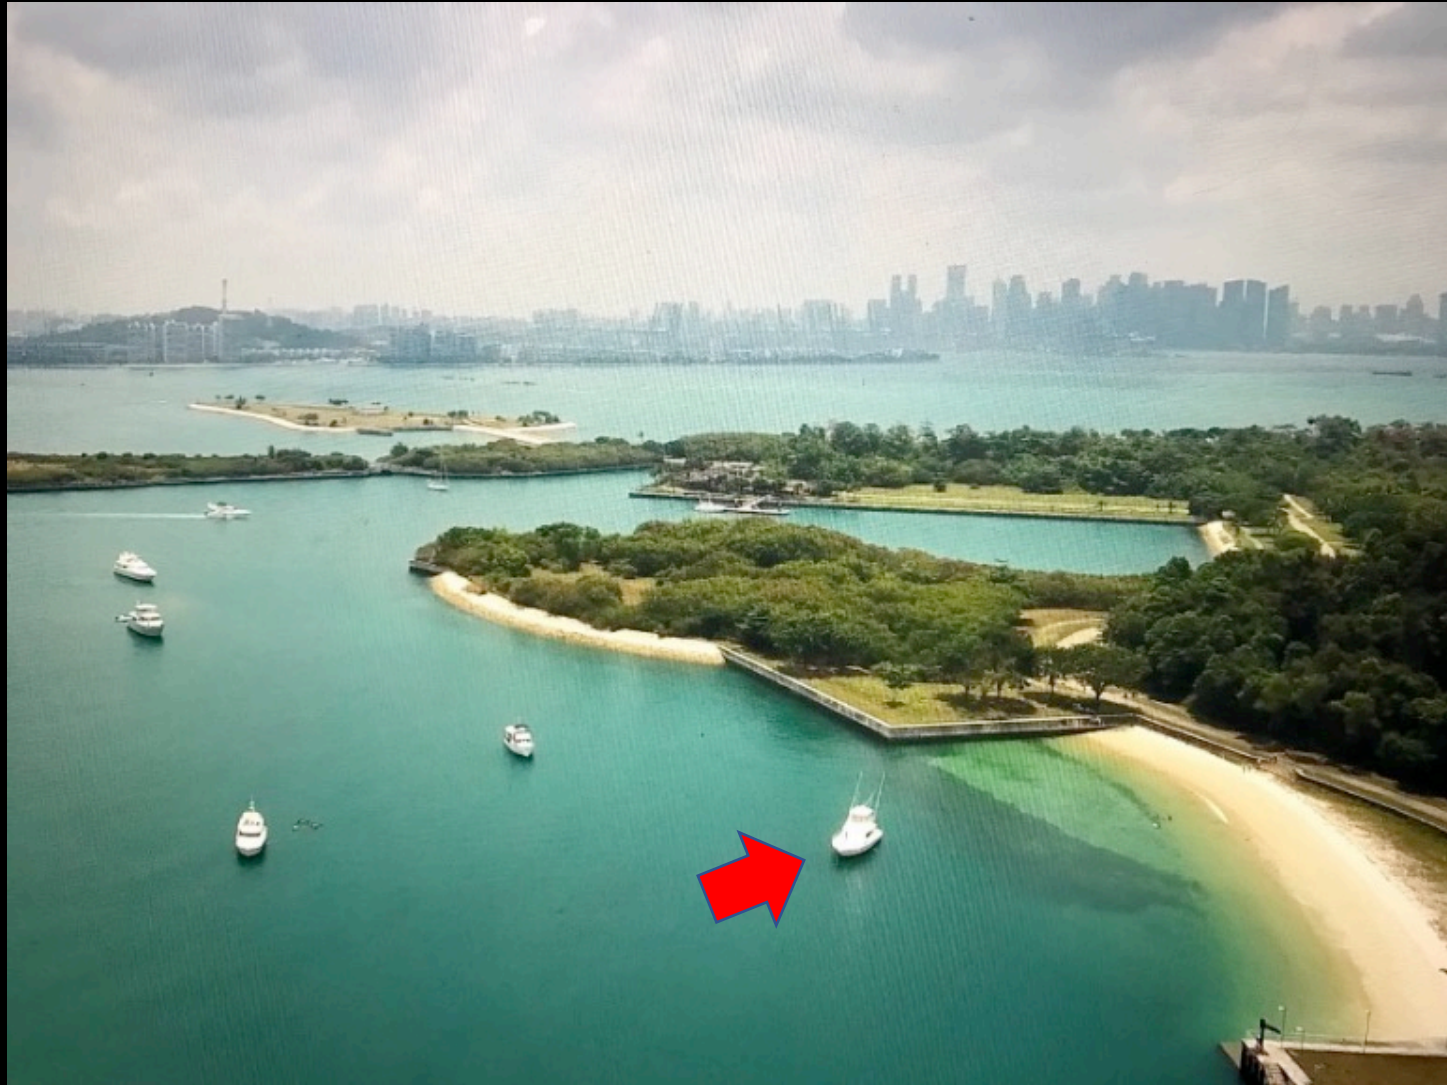
Vessel (arrowed) sometime later, after vessel swung onto reef during tide change

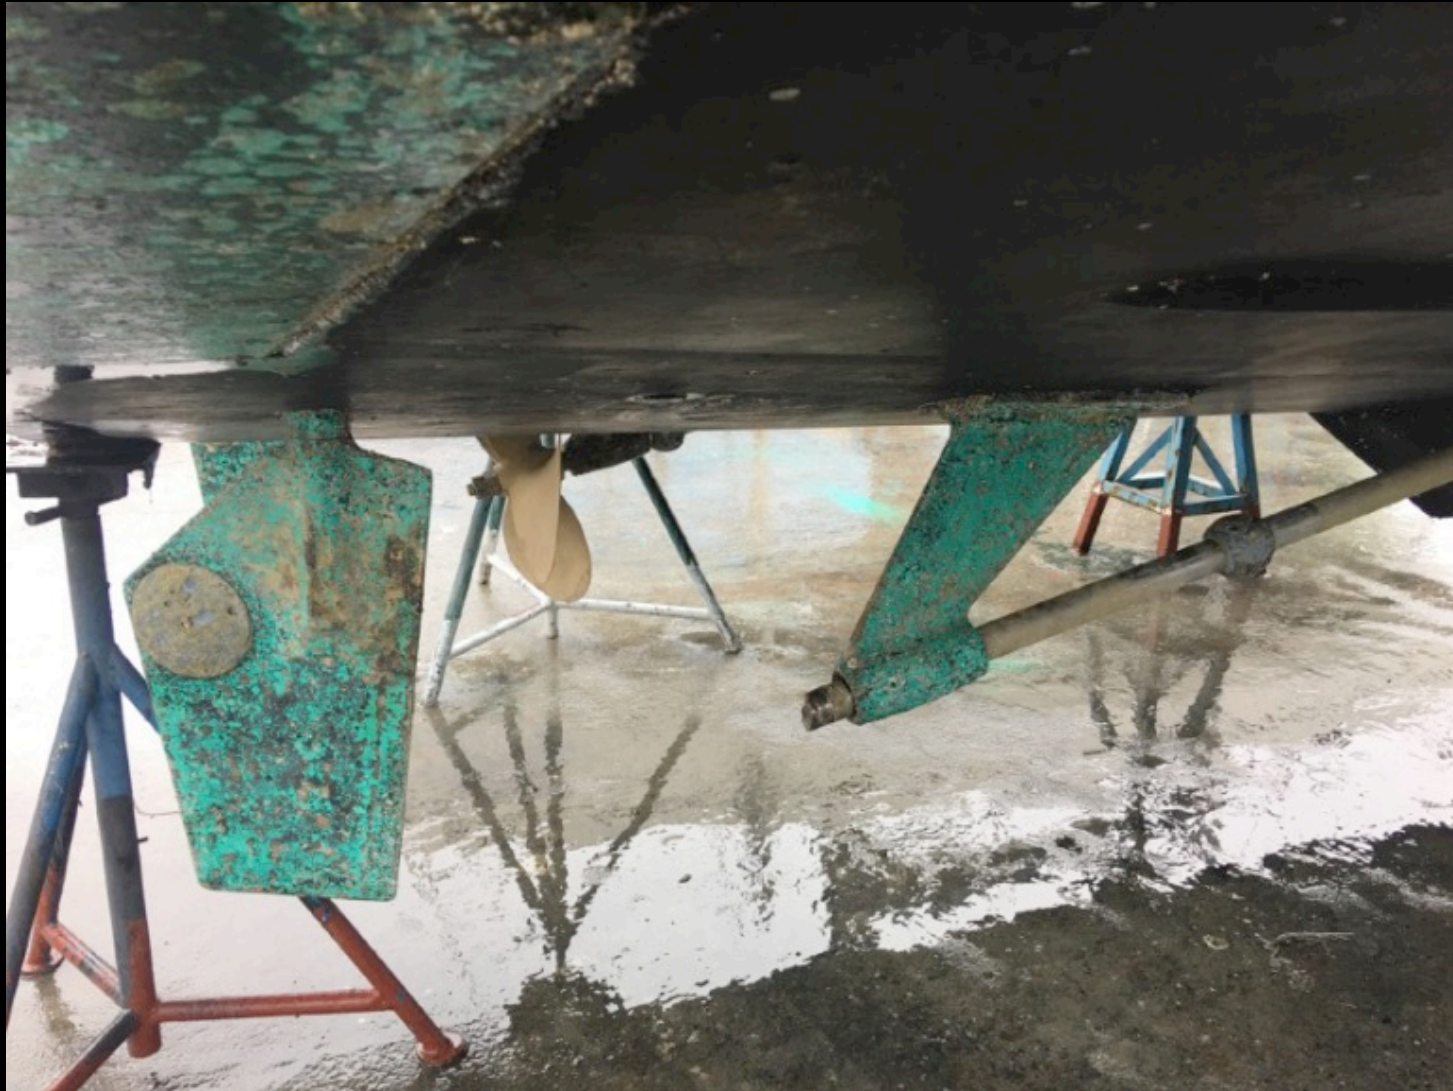
Sheered prop-shaft after moving ahead when prop was on reef
