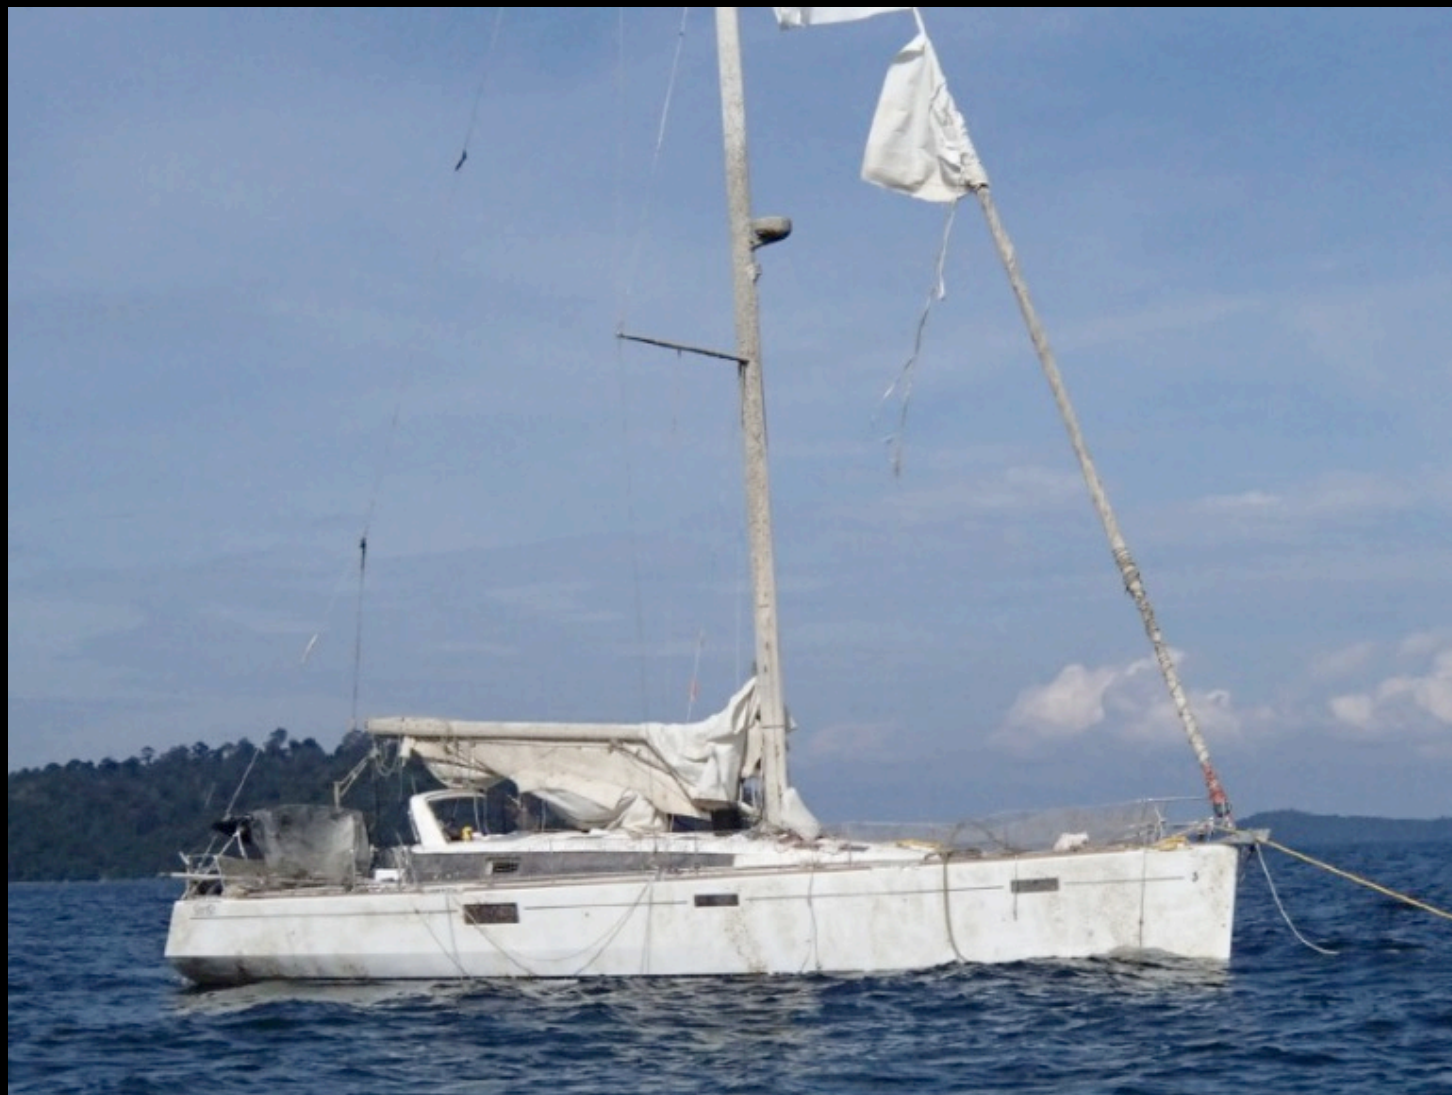
SINKING: Indonesia

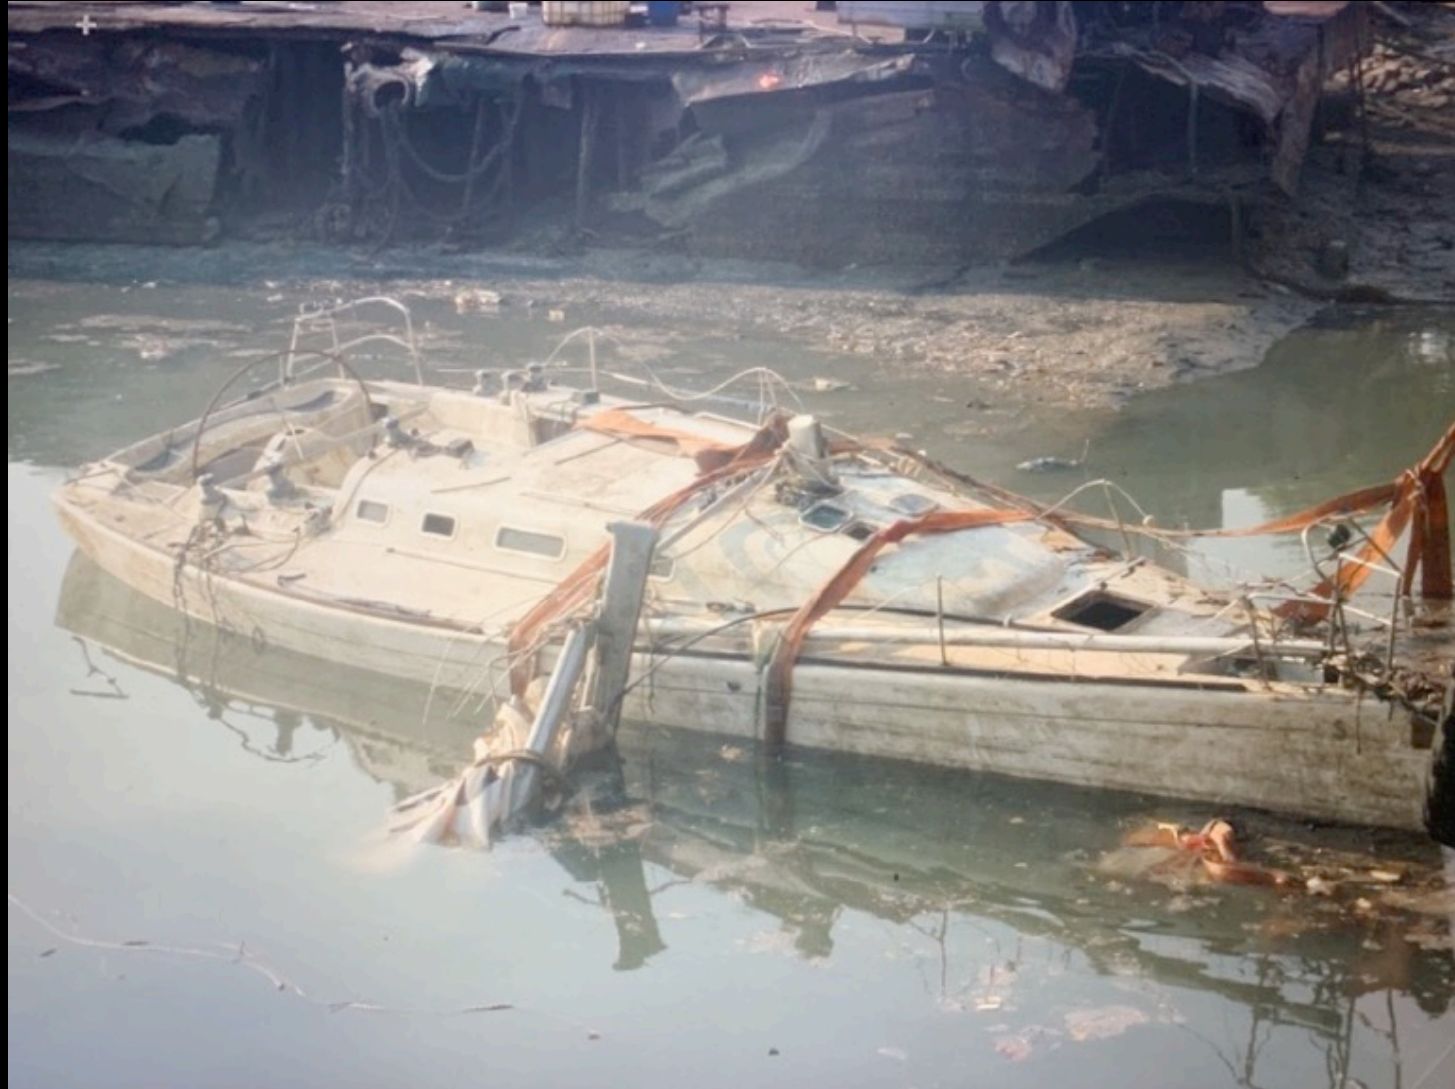
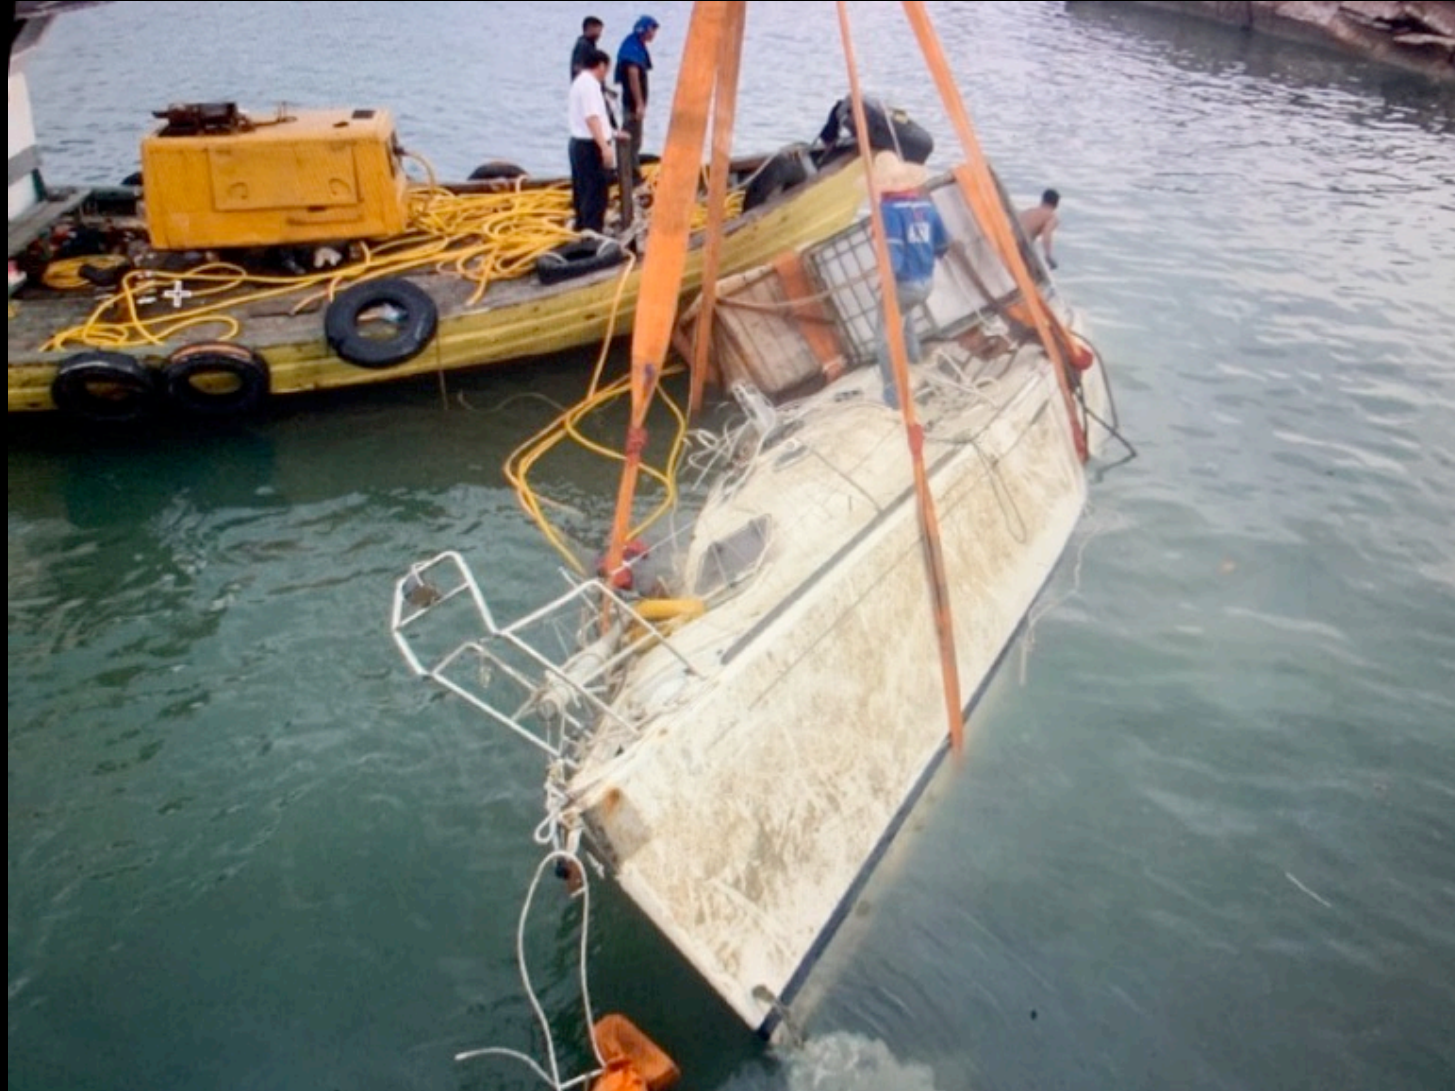
COLLISION WITH SHIP

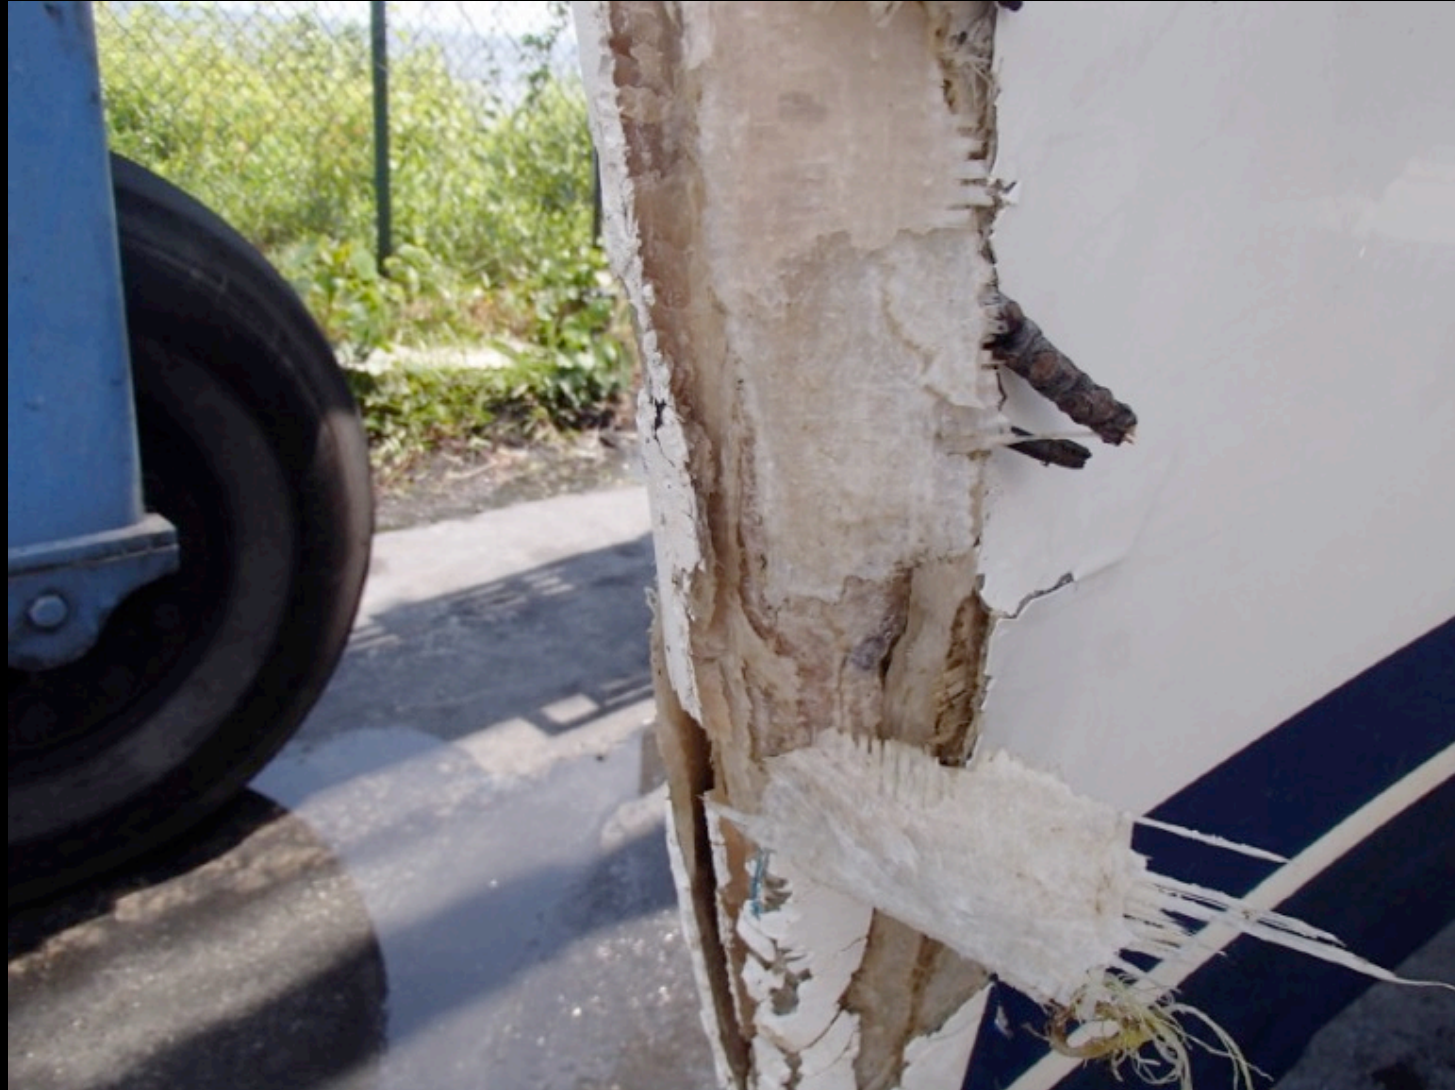
COLLISION

(Catamaran hulls frequently vertically delaminate at the stem)

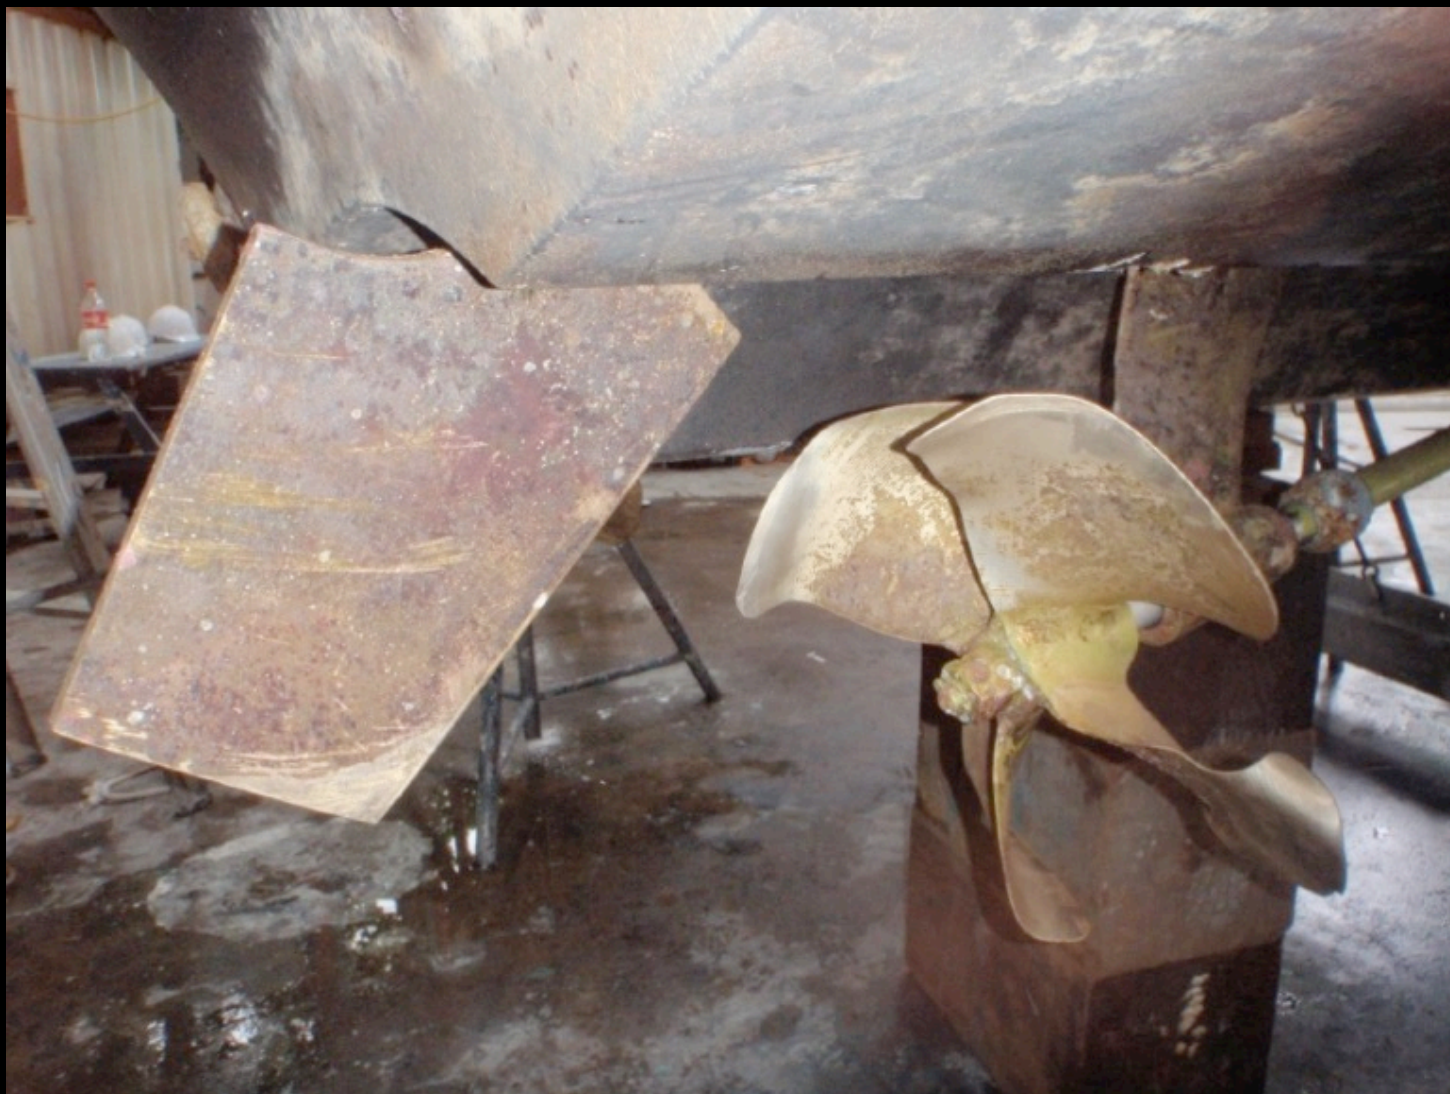
GROUNDING damage

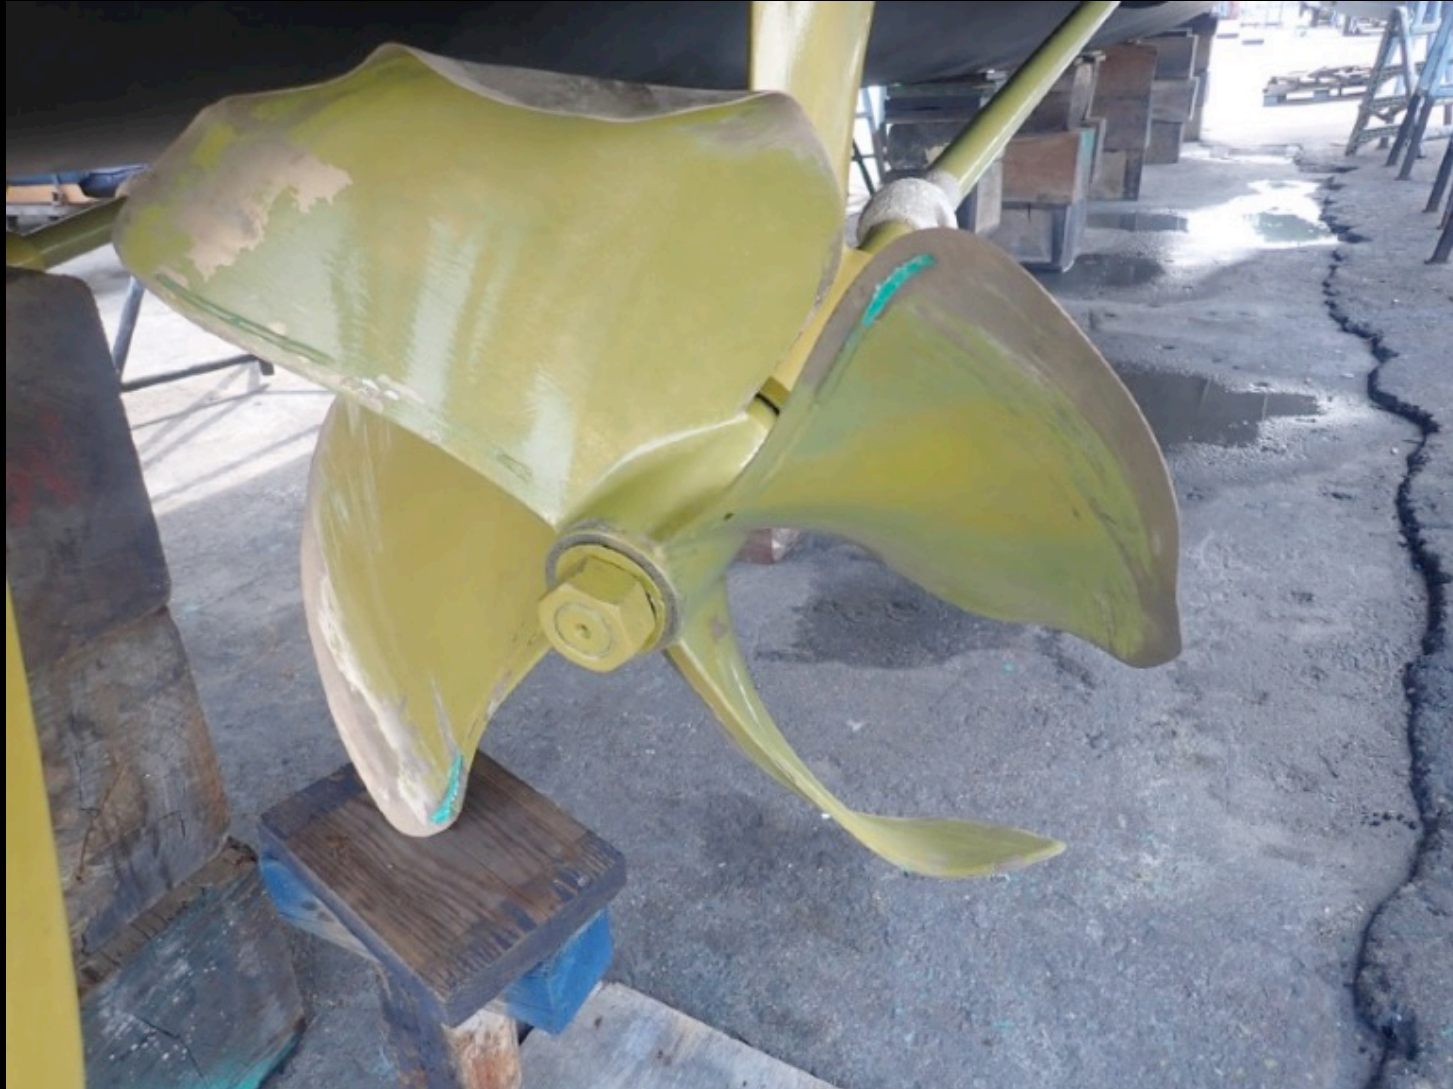
GROUNDING

- extensive damage requires replacement prop

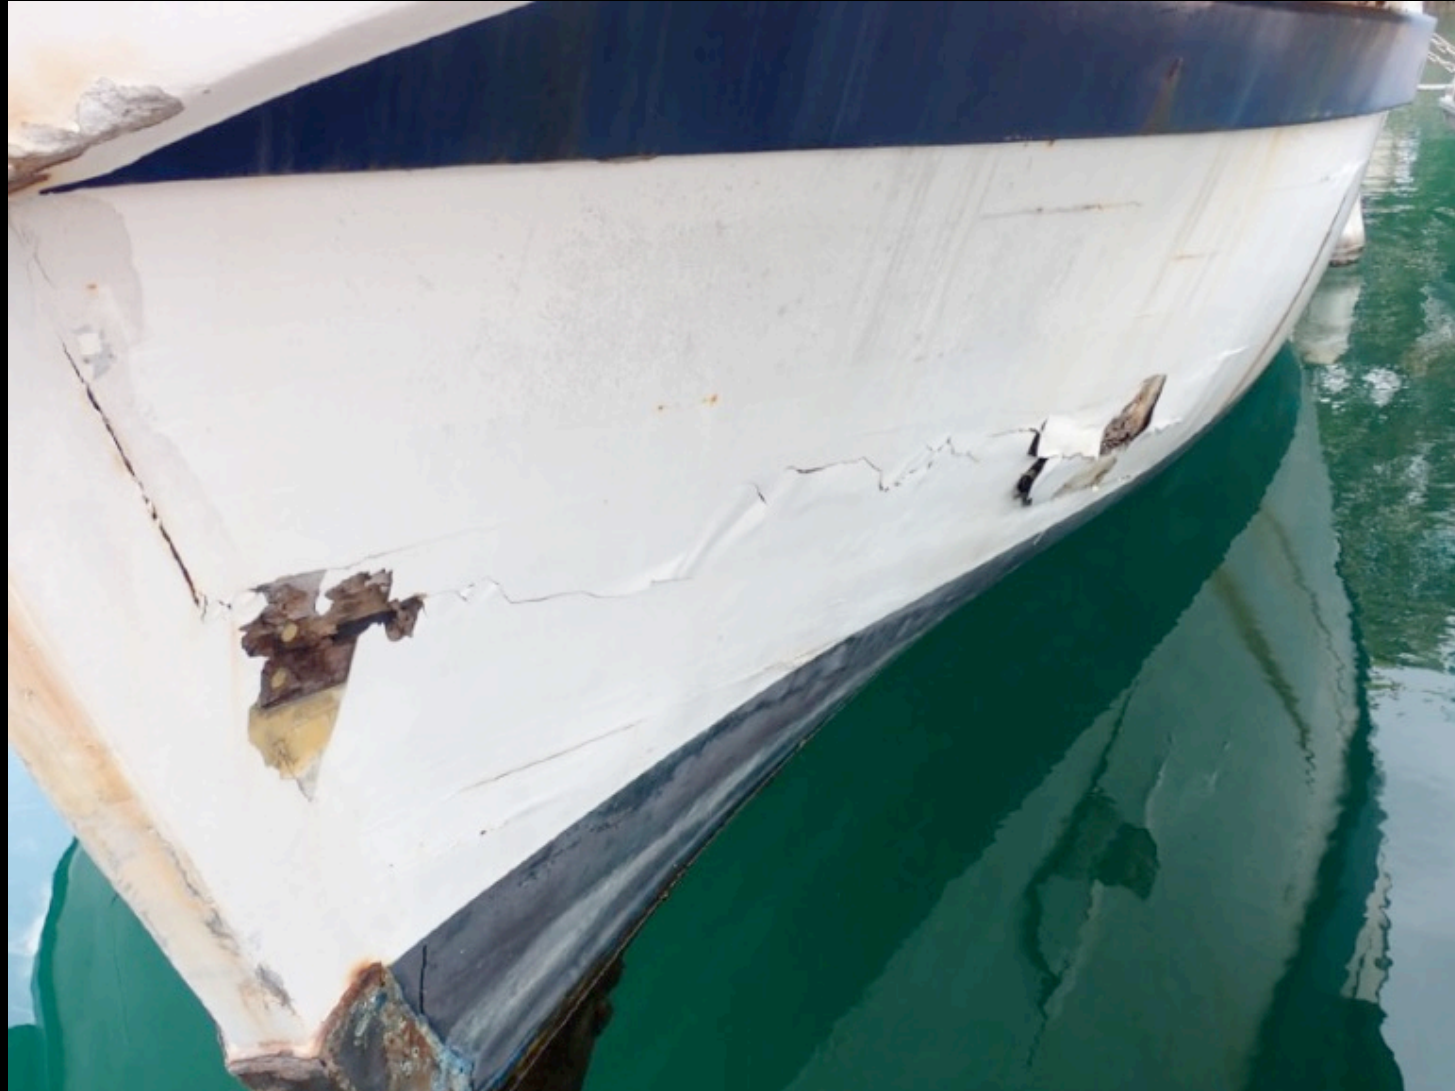
UNSEAWORTHINESS

– Rotted timber

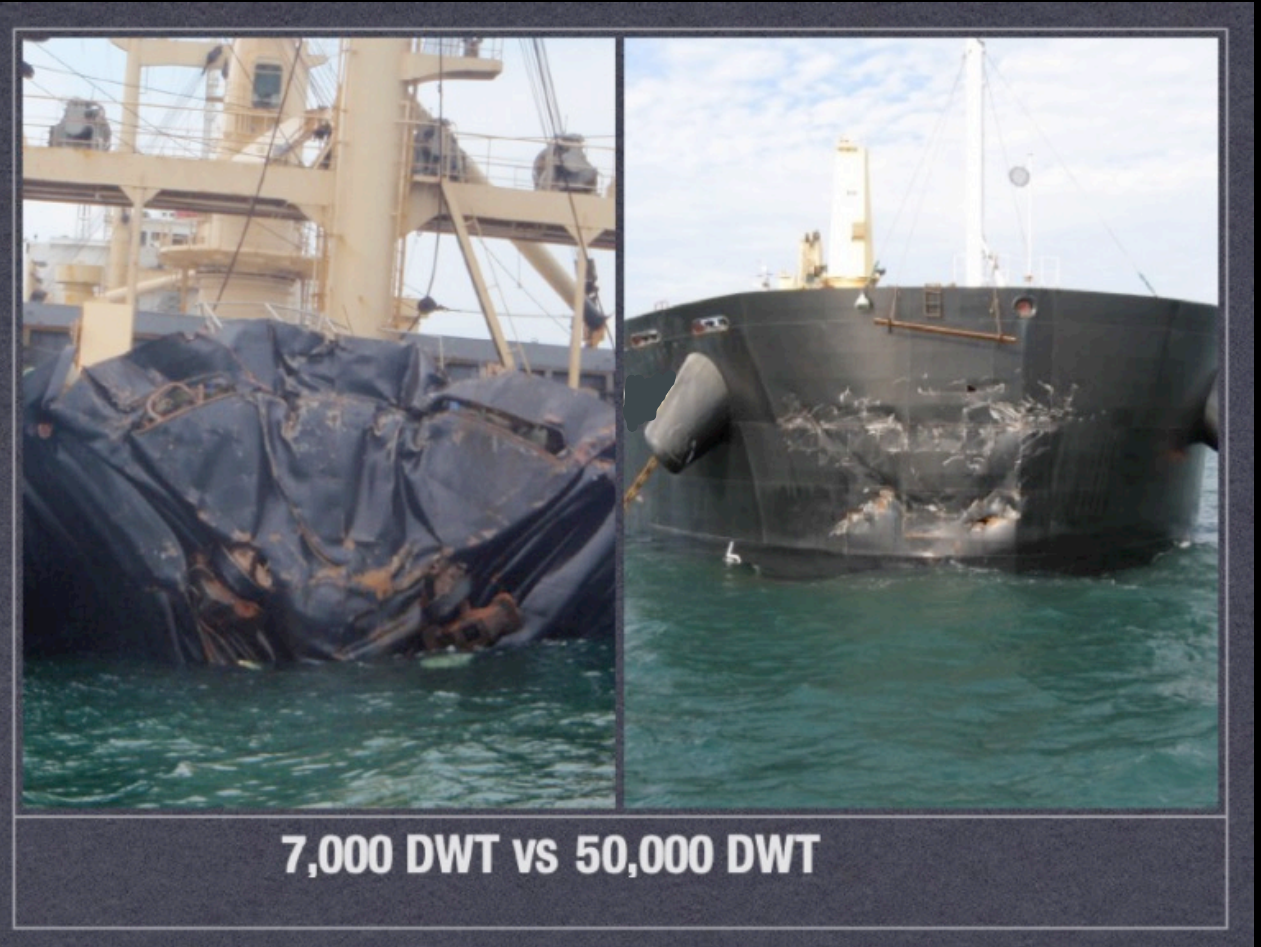
COLLISION - SINGAPORE STRAITS

COMPLEX SPEED & ANGLE OF BLOW

The smaller ship,
crossing the Singapore
Traffic Separation Zone,
was the give-way ship &
altered to starboard.

The large ship altered to
port....
